Introduction

The current evaluation was undertaken November 18, 2002 as part of an investigation of the root causes of filter media encrustation. Following replacement of the original anthracite coal and sand filter media after only five years of service, filtration capacity has again progressively been lost over the past two years.

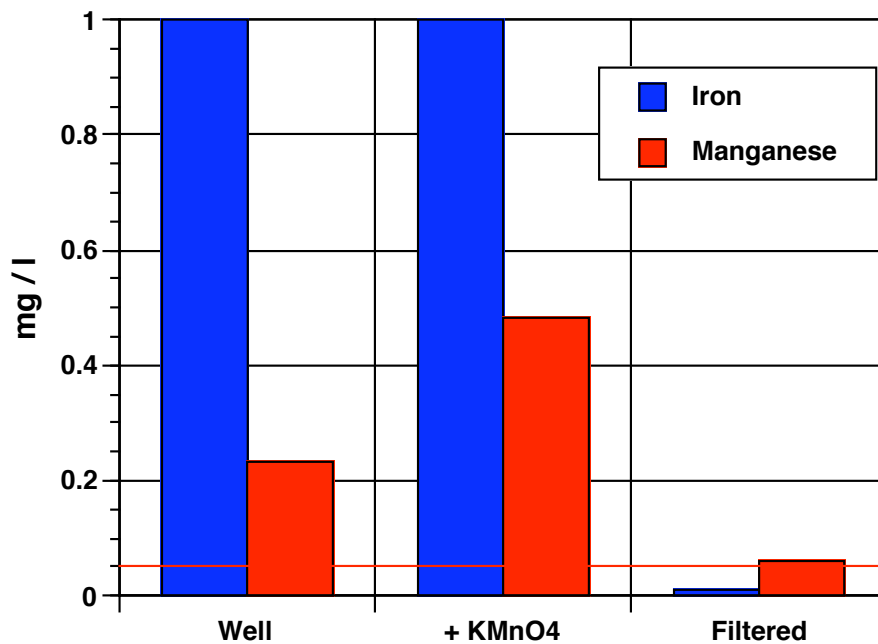
Accordingly, the Oakwood Road Water Treatment Plant was designed to remove the relatively small quantity of solids formed when iron and manganese are precipitated from Wells #11 and #12. The bar chart shown below illustrates the almost total (99%) removal of iron and the 80% removal of manganese in November 2002.

Manganese removals vary owing to the addition of potassium permanganate to the filter influent. Depending upon variations in feed rate, permanganate addition adds approximately 0.25 mg/l Mn to the influent water, bringing the total to roughly 0.48 mg/l Mn. Any transient overfeed of permanganate can result in the passage of 'pink water' plus increase the manganese concentrations in the filtered water. This suggests that the permanganate feed should be reduced to the minimum consistent with the maintenance of filtered water Mn concentrations less than 0.05 mg/l.

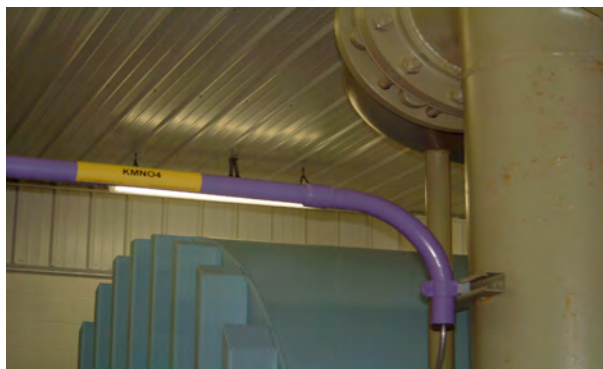
Permanganate is added to aerated water (filter influent) to oxidize manganous ion (Mn^{++}) to $Mn(OH)_4$, a brown-black precipitate.

To minimize solids application to the filter units, the permanganate addition should be reduced to the lowest possible effective dose. To assist in manganous ion removal, additional chlorine (up to a total of 3 mg Cl/l) should be applied at the aerator to supplant a portion of the permanganate demand and preclude biological growth on the filter media.

There are several operational reasons, in addition to chemical cost savings, for limiting the addition of permanganate. Primarily, it is very difficult to maintain a constant permanganate feed concentration, particularly, when the feed rate is as low as 0.25 mg/l. Overfeed results in the passage of soluble manganese and the appearance of 'pink water' in the effluent. The accumulation of additional manganese hydroxide in the filter adds to the rate of fouling and increases the need for more vigorous (higher rate) backwash.

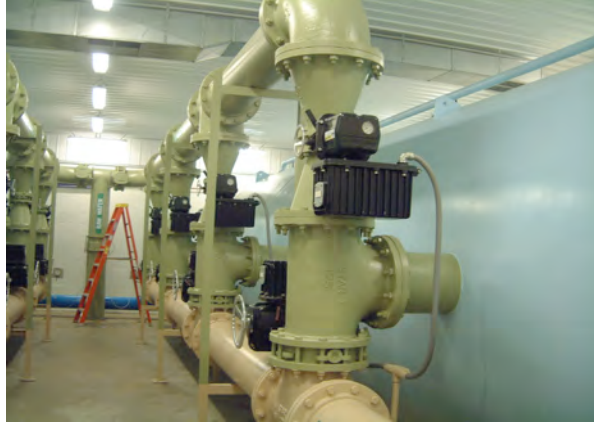
Horizontal pressure filters are divided into four compartments containing dual, crushed anthracite coal and coarse sand, media

The filter media in the Oakwood plant filters is comparatively coarse. A top layer of crushed anthracite coal (effective particle diameter, D_{10} , 0.6 to 0.8 mm) sits atop a support layer of silica sand (effective diameter, 0.8 to 1.2 mm). Normally, if the silica sand was to serve as a filter medium as opposed to a support for the coal layer, it would have an effective size in the range of 0.4 to 0.6 mm. These larger sand sizes would require considerably higher backwash flow rates for removal of any attached deposits.

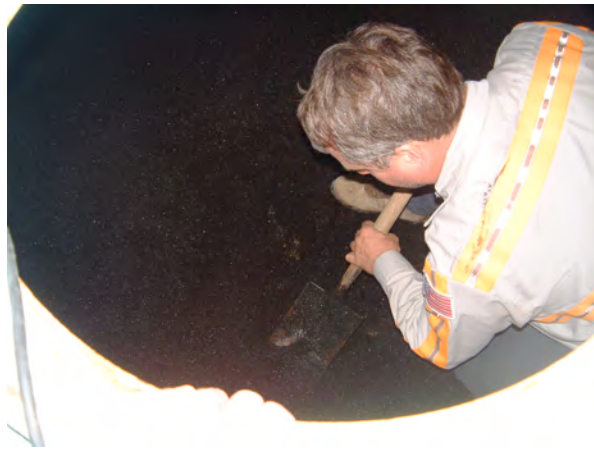
Filter media probing and sampling were conducted on November 18, 2002.

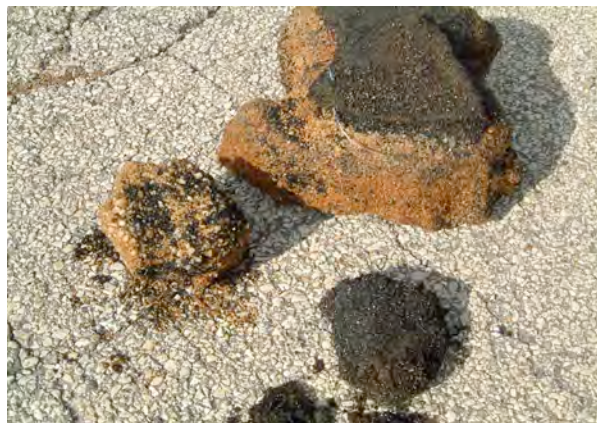
Most of the severely cemented (sandy) material appeared to underlie the coal layer. The coal media also showed evidence of a loose aggregation that could be broken up by hand.

From the most recent filter media sampling it appears that it is, primarily, the underlying sand layer that is undergoing cementation. This sand has already formed a horizontal lens that is rock hard, requiring a crowbar and hammer even to recover a sample for observation and analysis. Upon acidification, 24% of this sand layer sample, by weight, was lost. This is in marked contrast with the loss of 8.5% by weight following acidification of the coal layer.

From these analytical results, one can conclude that the iron and manganese hydroxides, once removed from the flow and attached to the media during filtration, are not being uniformly and effectively removed from the media particles during the backwash process. This has resulted in the progressive aggregation of the adjoining media particles until large areas of the filter bed have become unavailable for filtration. Aerated water may then travel along filter walls, through cracks, and bypass much of the filter surface. Poorer effluent quality and shorter filter runs are operational indications of the formation of concretions and the blinding of the filter media.

At the Oakwood Plant, aggregation appears to occur, primarily, within the sand layer immediately under the upper coal layer. This might be expected since the sand layer, being far greater in density (specific gravity, 2.6) as well as larger than the coal (specific gravity, 1.6), would not expand as much, if at all, during backwash. As a result, the surface deposition of calcium carbonate and iron oxides on the sand would be less efficiently removed.

Under the current circumstances, there seems to be little choice but to remove and discard the encrusted filter media before encroaching filter blockage reaches the point where water production is significantly impaired. However, the new replacement filter media should be selected so it will respond more appropriately to the filter backwash rates that can be achieved using the present system. This will require, at a minimum, the installation of a finer sand that will expand significantly during backwash. A deeper layer of 0.5 mm silica sand overlain by a shallower layer of crushed anthracite coal should improve the hydraulics of filter backwash.

It is recommended that the replacement filter media consist, primarily, of 0.55 mm silica sand with a 6-inch cap of 6 to 8 mm coal. The final design of this replacement media should be such that the silica sand layer will be expanded by 20% or more at a backwash rate of 10 gpm/sf.

Following removal of the cemented filter media, the filter units should be outfitted with an air injection system. The distribution piping (nonmetal) for this system should be located beneath the silica sand filter layer, preferably, within the underdrain system.

The operational protocol for the air scour should include the drawdown of the water level in the filter to below the effluent launders in order to avoid loss of filter media over the effluent weirs. Although operational experience may lead to a refinement of the air-assisted backwash procedure, initially, the air should be applied at a rate of 2 ft³/min/ft² for a period of five minutes prior to the start of backwash.

After the air is shut off, the filters should be backwashed at a rate of 10 gpm/sf until the wash water is clear. Records should be kept of the quantity of wash water required.
